Printing issue related to Windows printer driver dithering setting

A printing issue was discovered with the dithering function of the SATO Windows printer driver.

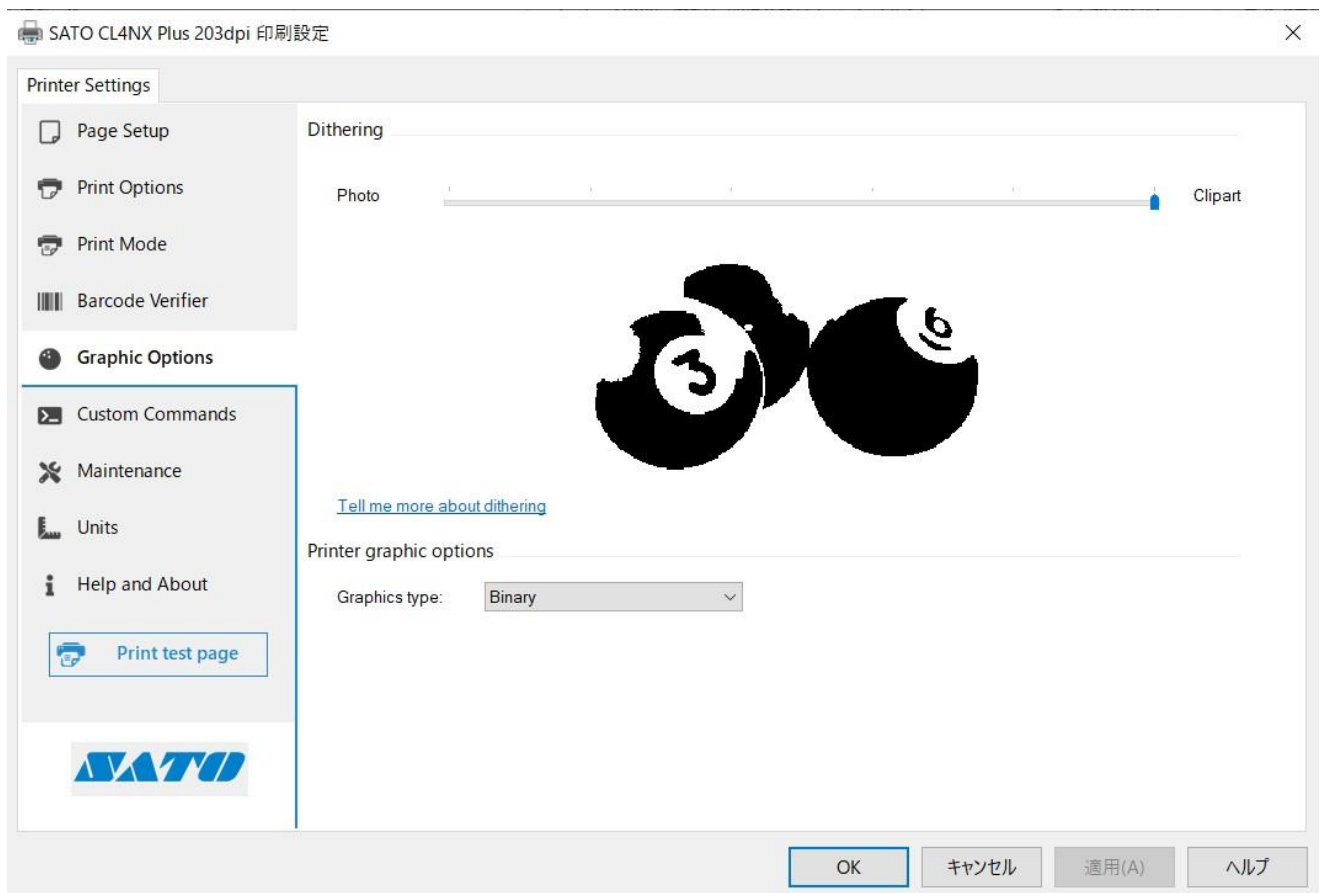
The error has been observed when changing the dithering setting of printer driver version 8.4.9.27651 from the default value ("Clipart")

When printing with Windows printer driver 8.4.9.27651 and the dithering setting is changed to anything other than the default setting ("Clipart"), print results may differ from earlier versions of the driver. This is caused by a dithering function failure and may be more visible when there are tone expressions (colour or greyscale images) in the print layout.

Please download the latest driver here →
